**Maryland Historical Trust
State Historic Sites Inventory Form**

Survey No. B-4402

historic 409-411-413 West Saratoga Street

street & number 409-411-413 W. Saratoga Street not for publication

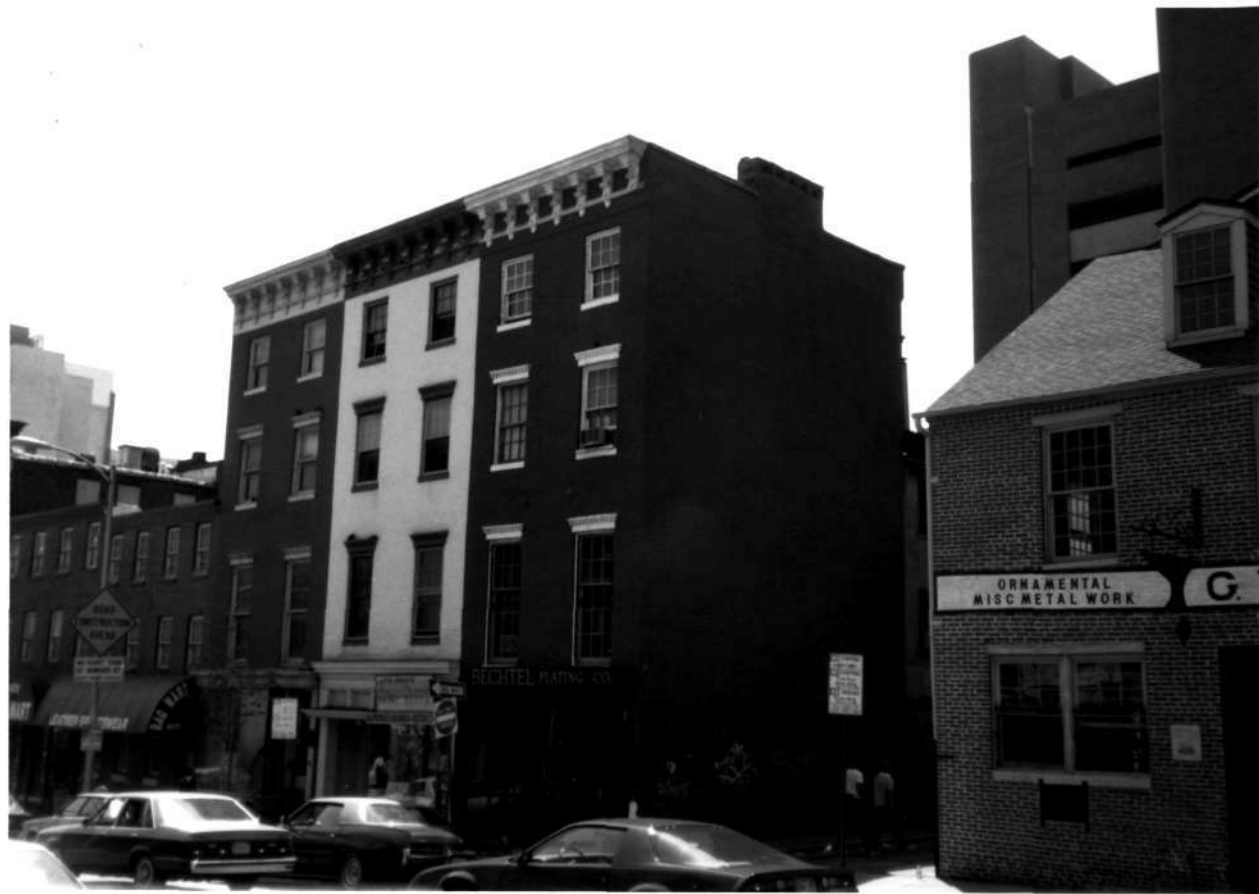
1/4

This circa 1850-1860 Italianate brick commercial block building faces north on West Saratoga Street and abuts a partywall structure to the east and a modern alley to the west. The building is four stories high and six bays wide. It is divided into three two-bay units, each painted a different color. Each store front has different architectural treatments, but the upper stories are similar and there is no seam in the brick work between the units.

Facade, NW elevation

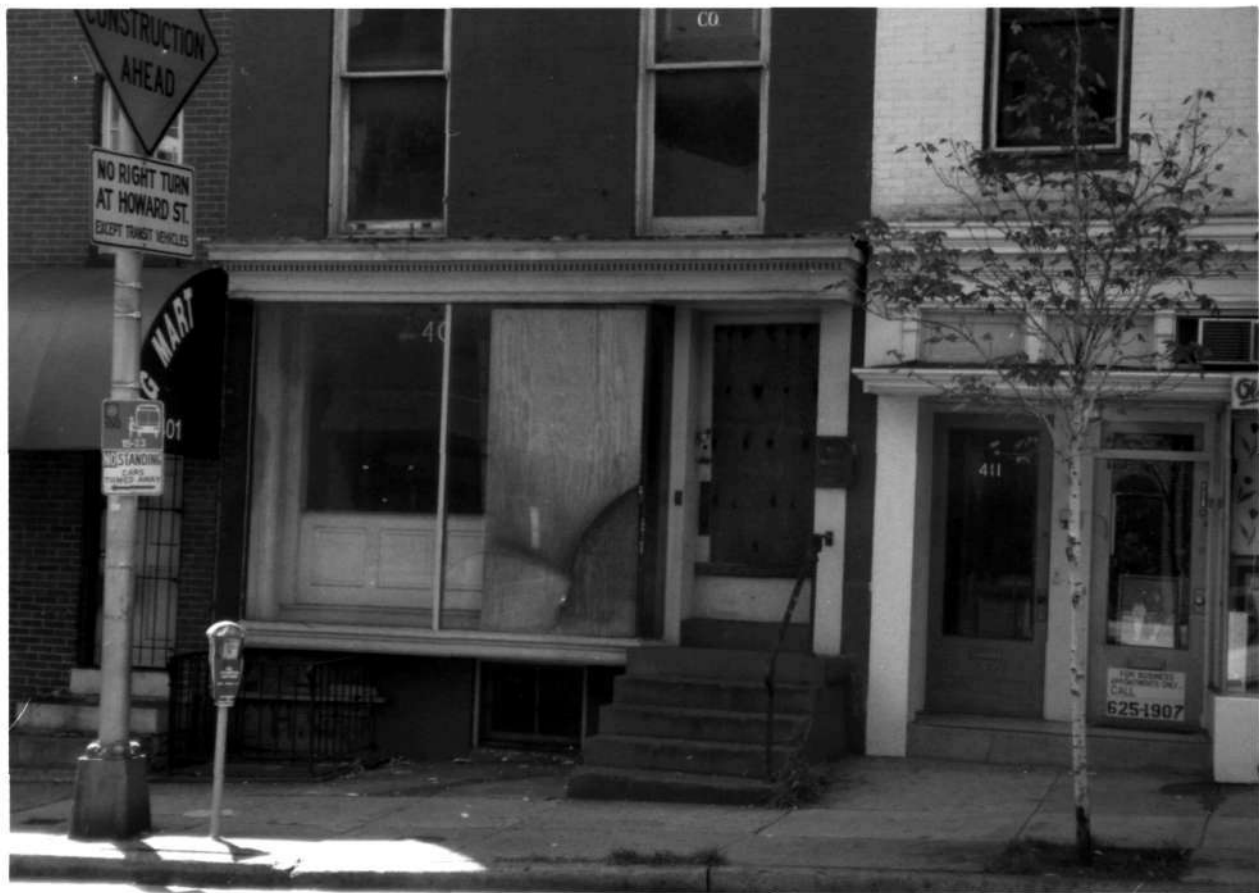
2/4

The first story of #409 is composed of a large display window that almost fills the facade. The display window is boxed and projects beyond the plane of the facade. The plate glass is modern, but the opening and window surrounds are original. The base of the windows have molded trim of Greek ovolo, two fillets, cove, bead, fillet, back band bead and fillet. The display base has low, five-panelled backdrop behind it. The entrance is to the far western edge of the second bay and is flush with the facade. The entrance is reached by six steps. Through the glass door one can see that there is a door to the east that opens into the first floor and a stair hall to the south that runs straight up the west wall. A pent roof covers the bow of the display window and shelters the entrance.

Facade, detail

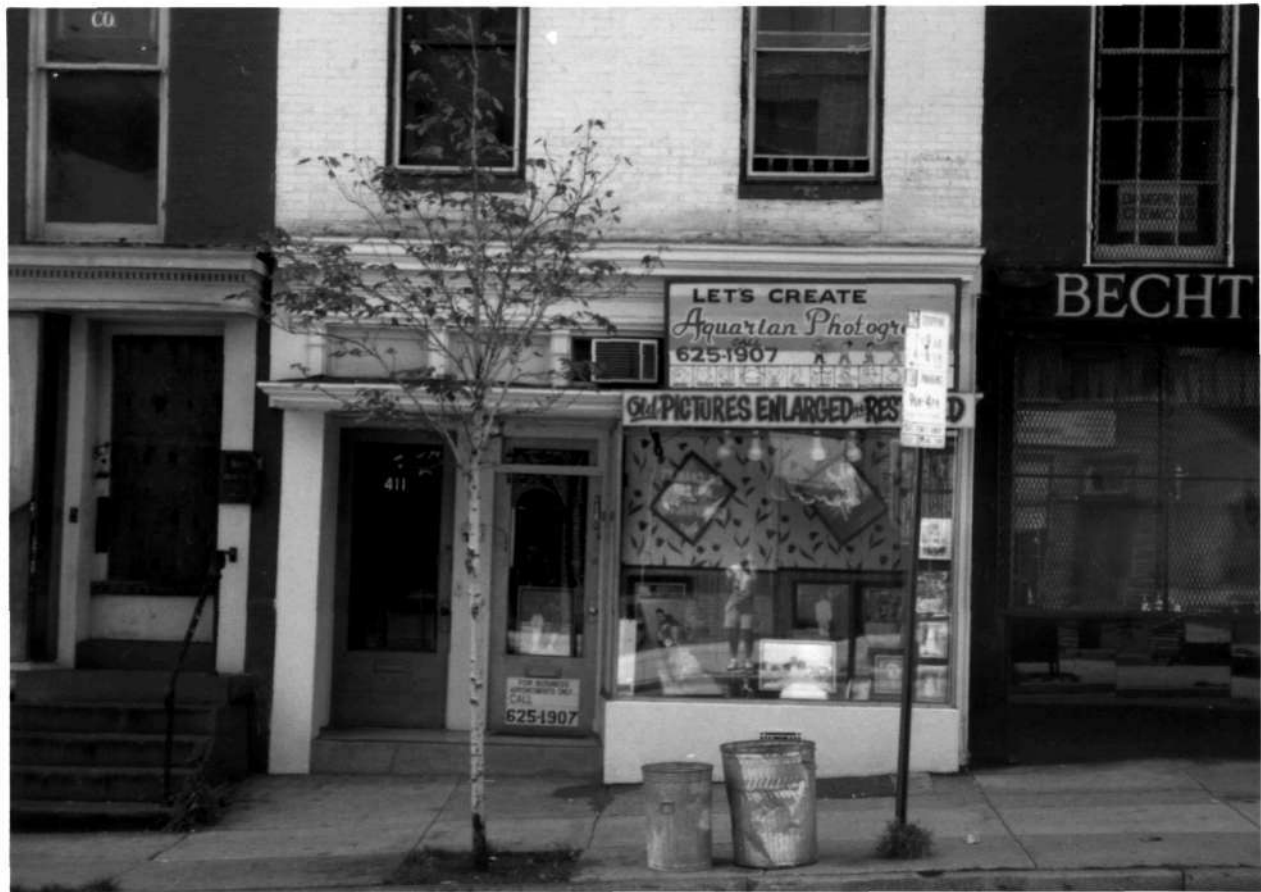
3/4

The first story of #411 contains two recessed entrances in the first bay and a display window in the second. The glass doors have wood surrounds. The first door leads to an enclosed vestibule with a landing that leads down the hall to a stair that rises along the back south wall. The second door leads to the first floor commercial space. Recessed field panels line the walls and soffit of the recessed entrance. The floor is tiled in white hexagonal tiles. The display window projects slightly beyond the plane of the facade. The large plates of glass are modern, but the overhanging cornice and sign board above the opening are original. The cornice extends across the width of the facade and forms a porch over the recessed entry. The profile of the cornice is fillet, two ogees and two fillets. A series of five transom windows run across the top of the cornice. The pilasters are divided by pilasters and surmounted by an ornate cornice of fillet, ogee, two fillets, two back bands, a quarter round, cove, back band, cove, and fillet trim.

Facade, detail

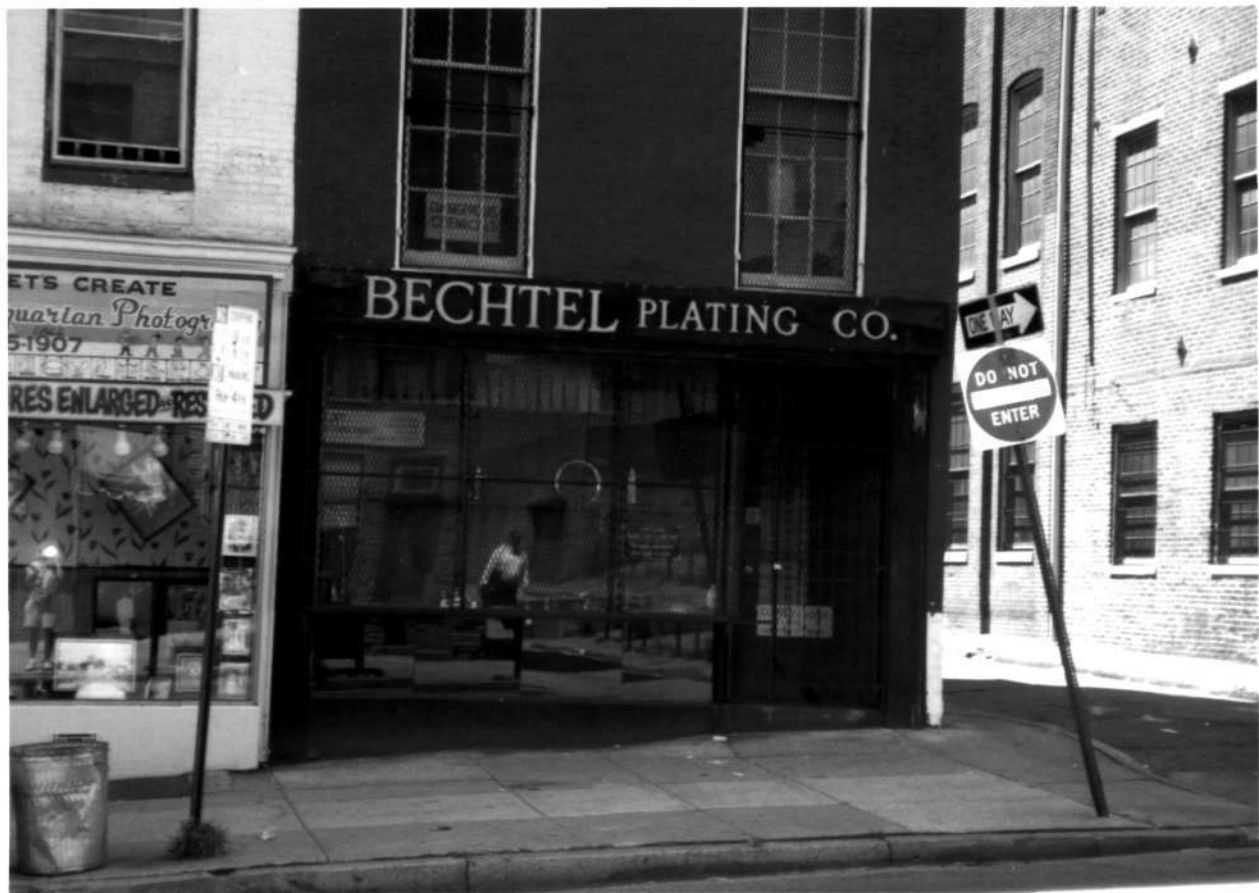
4/4

The first story of #413 has been resurfaced with black vitrolite panels that border the display window and east section of the wall. The display window almost fills the two bays, with the entrance in far western side of the second bay. The door is set in an angled recess. The door is glass with wood surrounds and it has a narrow transom. A metal sign board runs across the facade under the second story windows. Remnants of the original door surrounds and window cornice remain. A metal security grill is bolted over

Facade, detail
